CENTRAL VALLEY REGIONAL WATER QUALITY CONTROL BOARD

INSPECTION REPORT

LOCATION & COUNTY: Henry Tosta Dairy
20662 San Jose Road, Tracy
San Joaquin County

INSPECTION DATE: 22 October 2012

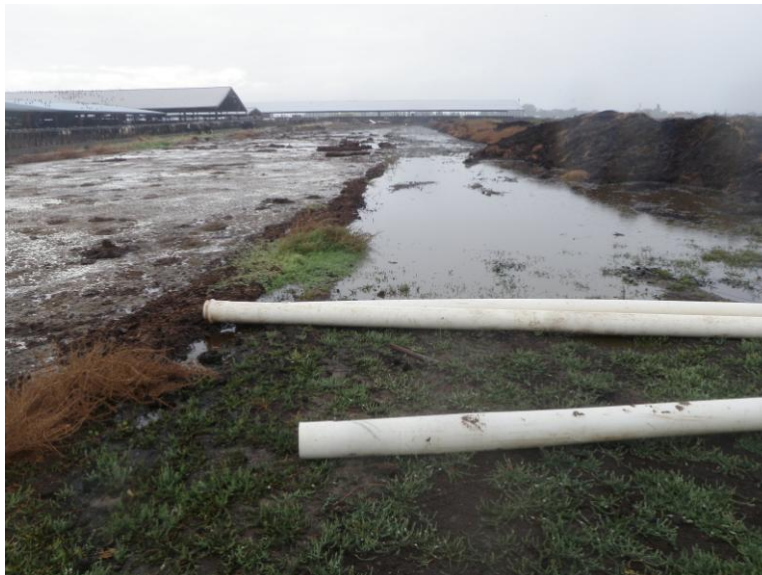
Photo 1: Settling Basin #1 is in the same condition as the 10 October 2012 inspection; wastewater is over-topping the eastern and western embankments.

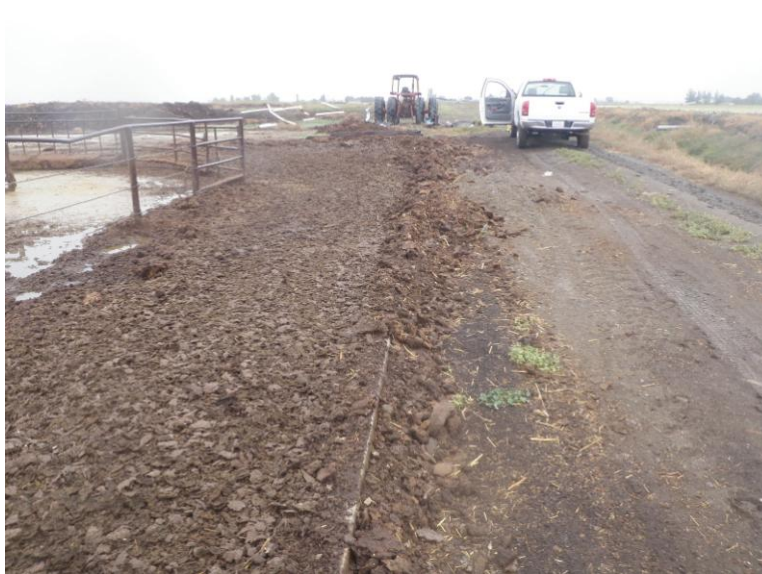
Photo 2: A small manure berm was constructed to ensure wastewater that is over-topping the embankments at Settling Basin #1 will not discharge south across the road and into the Naglee-Burk Irrigation canal.

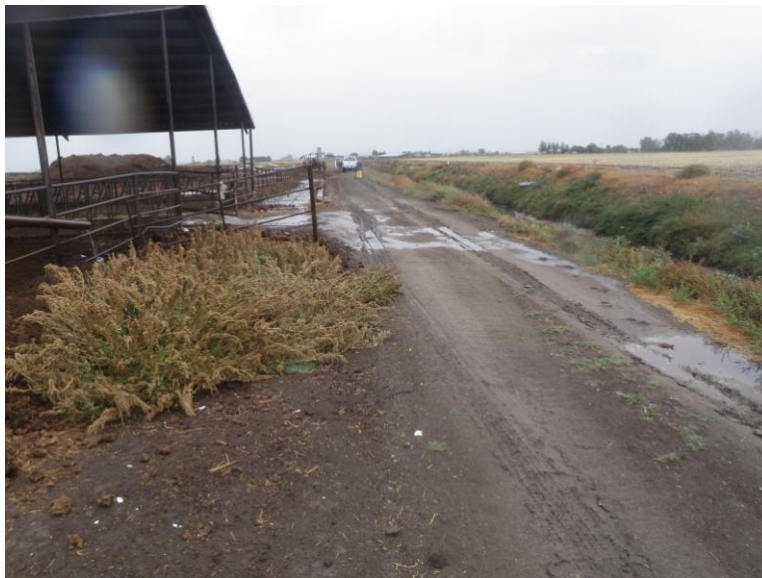
Photo 3: Roof water is directed through the corner of the corral which contains solid and slurry manure. At the time of our inspection the volume wasn't enough to discharge off-property.

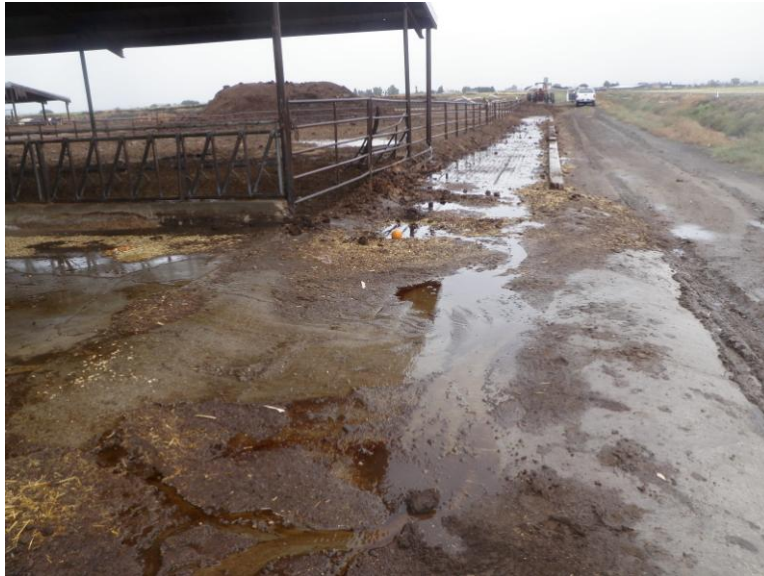
Photo 4: Roof water is directed through the corner of the corral which contains solid and slurry manure. At the time of our inspection the volume wasn't enough to discharge off-property.

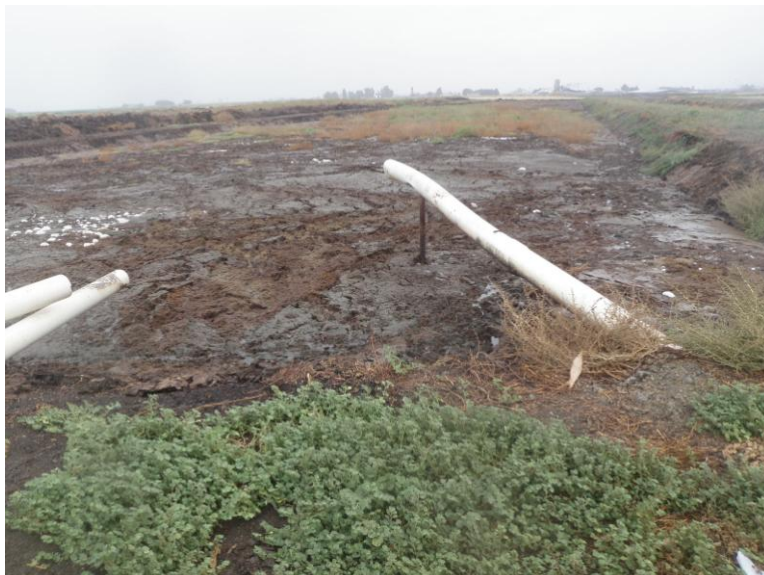
Photo 5: Settling Basin #2. Staff observed a significant amount of solid manure and wastewater inside the basin.

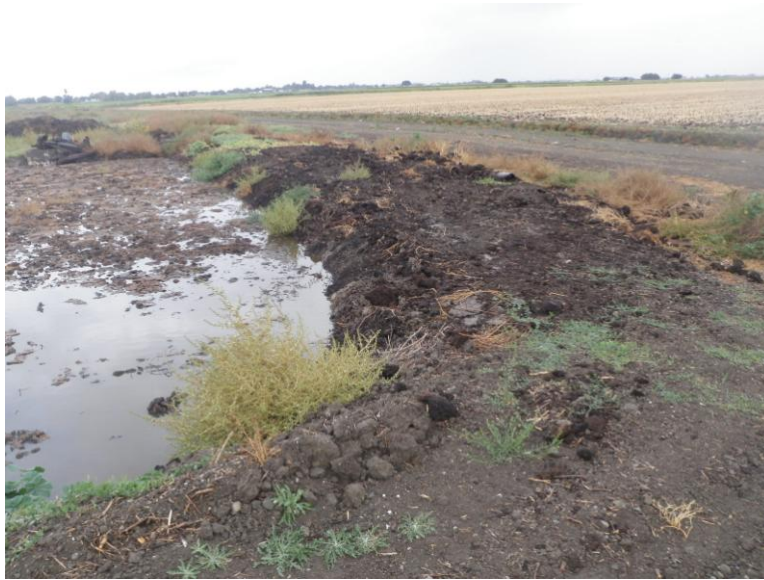
Photo 6: Eastern-end of Settling Basin #2; solid manure is still being used to reinforce the eastern embankment.

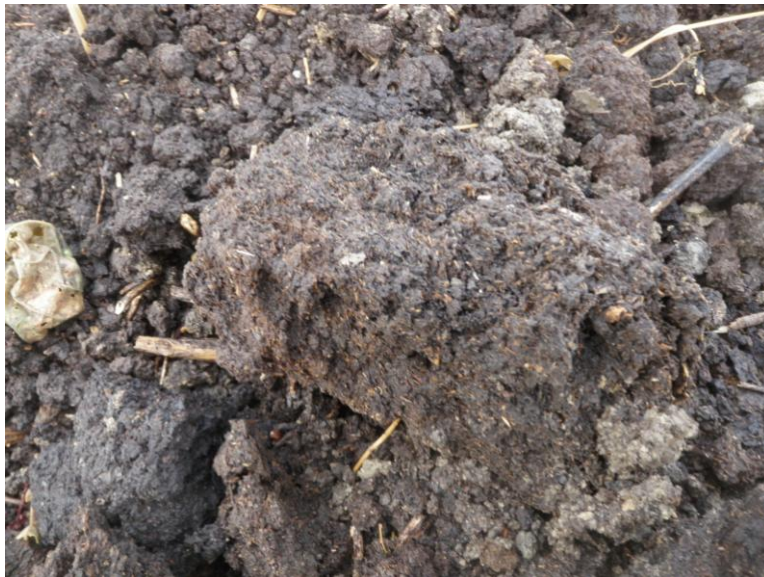
Photo 7: The material being used to reinforce the eastern embankment at Settling Basin #2; note the fiber in the pictured piece of solid manure. The operator claims this is not manure but clean fill dirt.

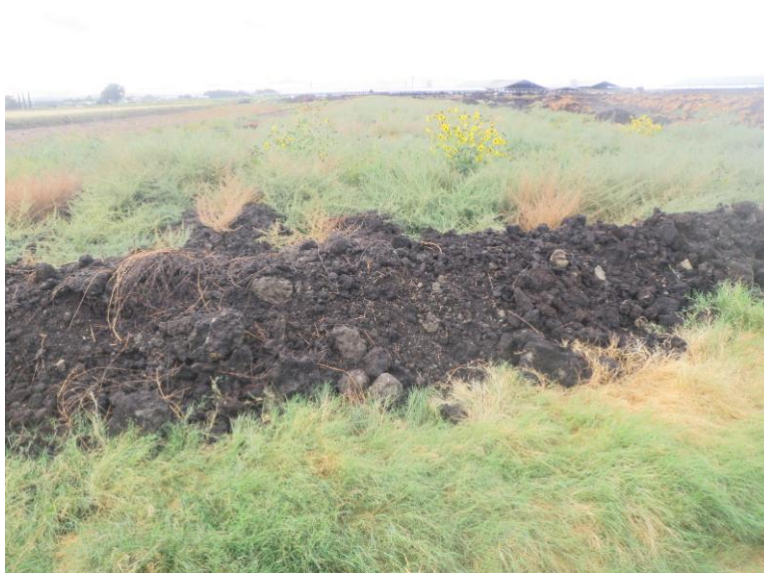
Photo 8: Wastewater Lagoon #1. A significant amount of weeds makes determining lagoon dimensions or lagoon embankment integrity almost impossible.

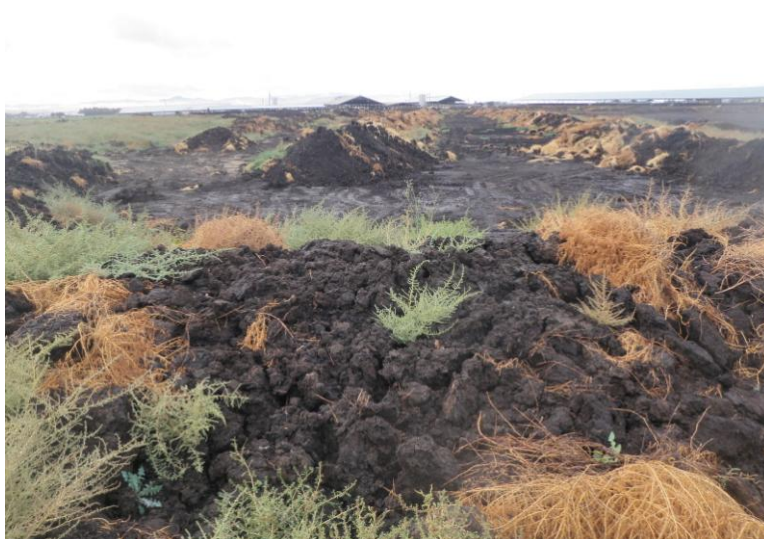
Photo 9: Wastewater Lagoon #2. The windrows of solid manure inside this lagoon appear to be dry and ready to export and/or land-apply.

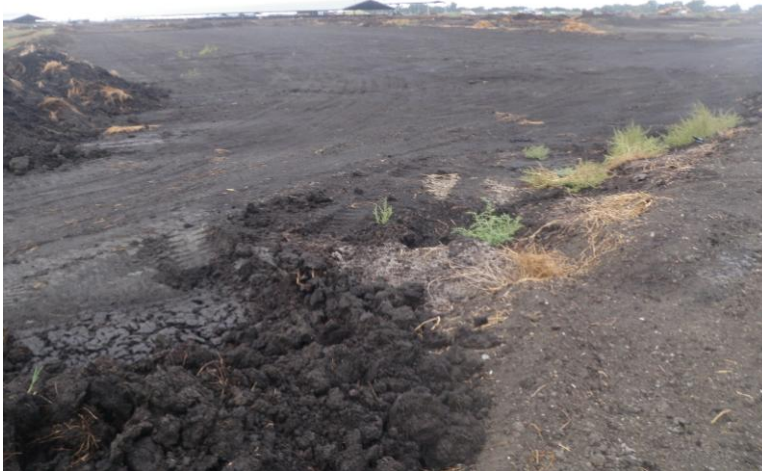
Photo 10: Wastewater Lagoon #3 is in the same condition as at the 10 October 2012 inspection.

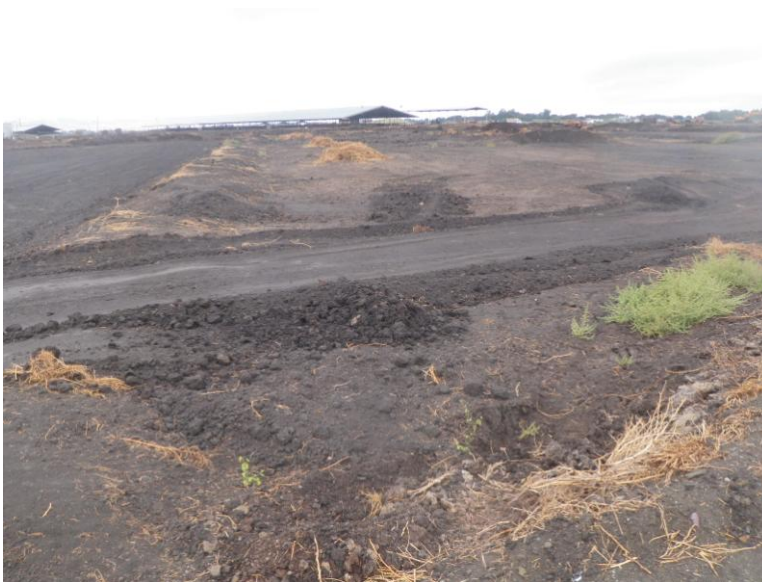
Photo 11: Wastewater Lagoon #4. Besides using the western portion to dry manure from the 3-4 acre slurry area (Photo 13), and cutting a notch into the western embankment to gain access from the 3-4 acre slurry area (Photo 14), the basin is in the same condition as at the 10 October 2012 inspection.

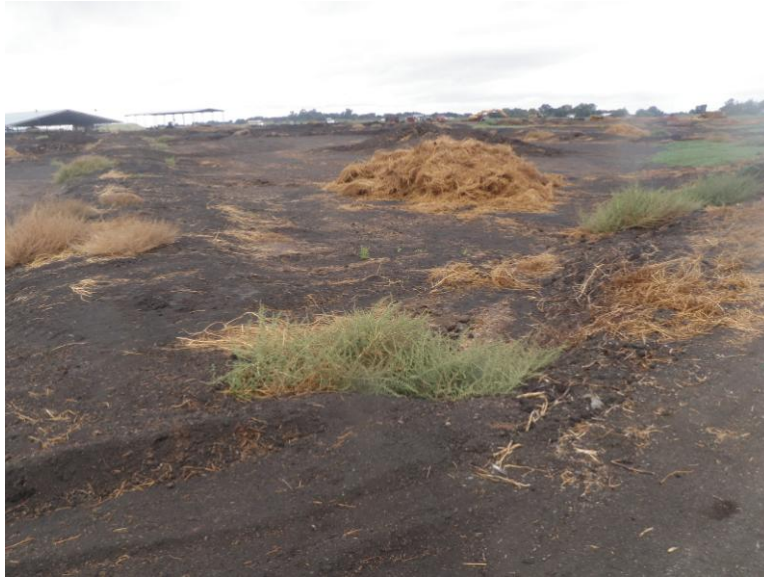
Photo 12: Wastewater Lagoon #5. Besides using the western portion to dry manure from the 3-4 acre slurry area (Photo 15), the basin is in the same condition as at the 10 October 2012 inspection.

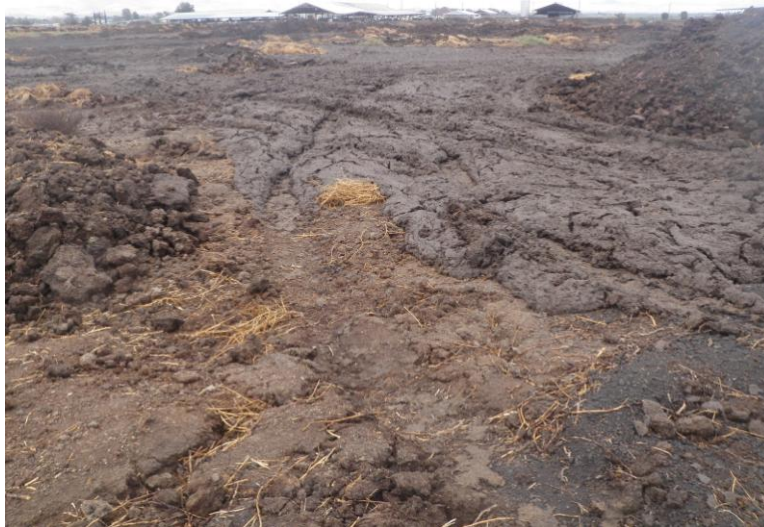
Photo 13: Wastewater Lagoon #4 is being used to dry manure.

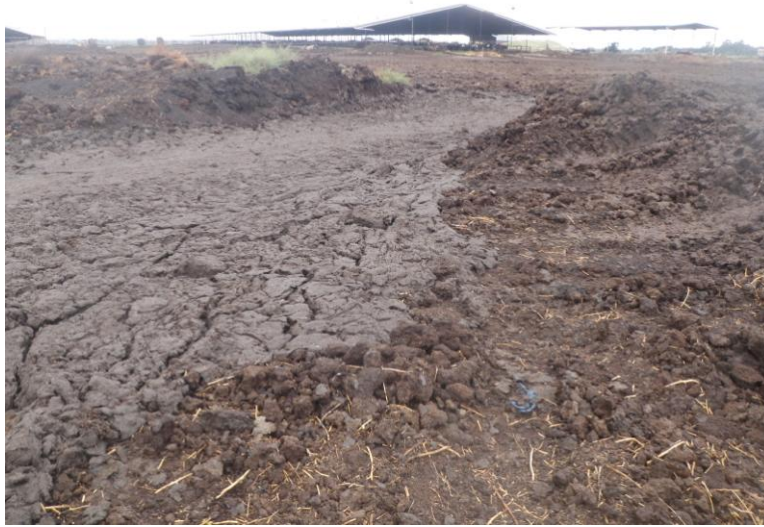
Photo 14: A notch has been cut into the western embankment at Wastewater Storage Lagoon #4. Staff assumes the purpose is to access the lagoon from the 3-4 acre slurry area so manure from the slurry area can be stacked in Lagoon #4 to dry.

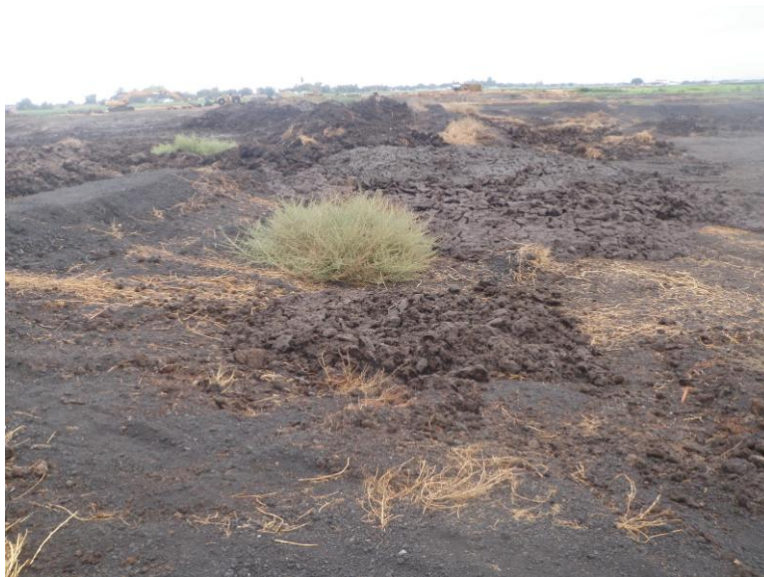
Photo 15: Wastewater Lagoon #5 is being used to dry manure.

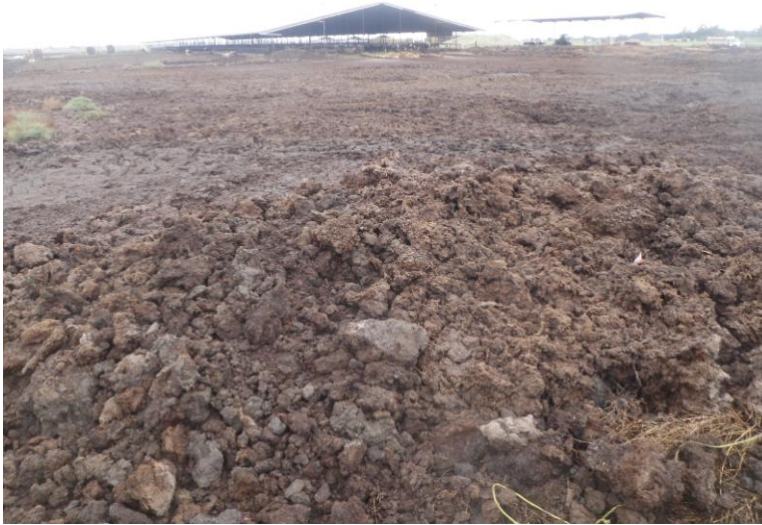
Photo 16: Looking west at the 3-4 acre slurry area; the area still contains a significant amount of solid manure, slurry manure, and wastewater.

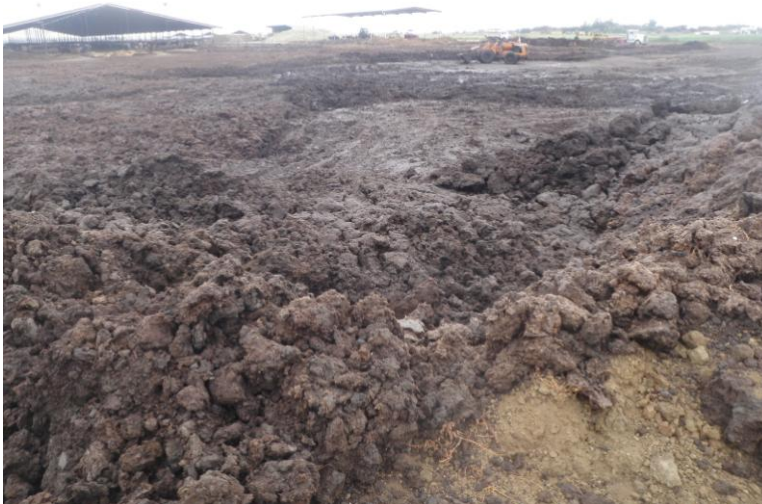
Photo 17: Looking west at the 3-4 acre slurry area; the area still contains a significant amount of solid manure, slurry manure, and wastewater.

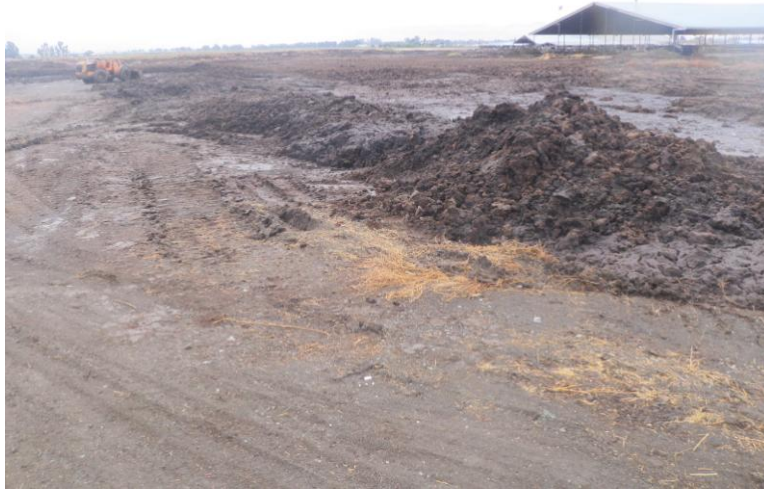
Photo 18: Looking south at the 3-4 acre slurry area; the area still contains a significant amount of solid manure, slurry manure, and wastewater.

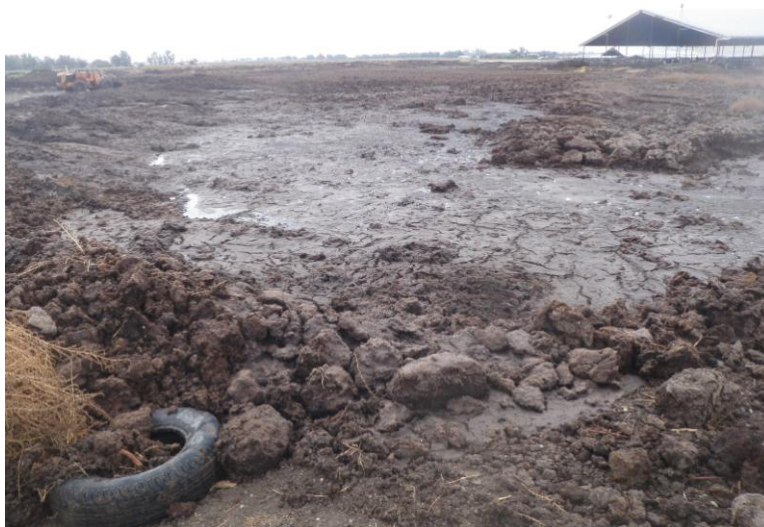
Photo 19: Looking south at the 3-4 acre slurry area; the area still contains a significant amount of solid manure, slurry manure, and wastewater.

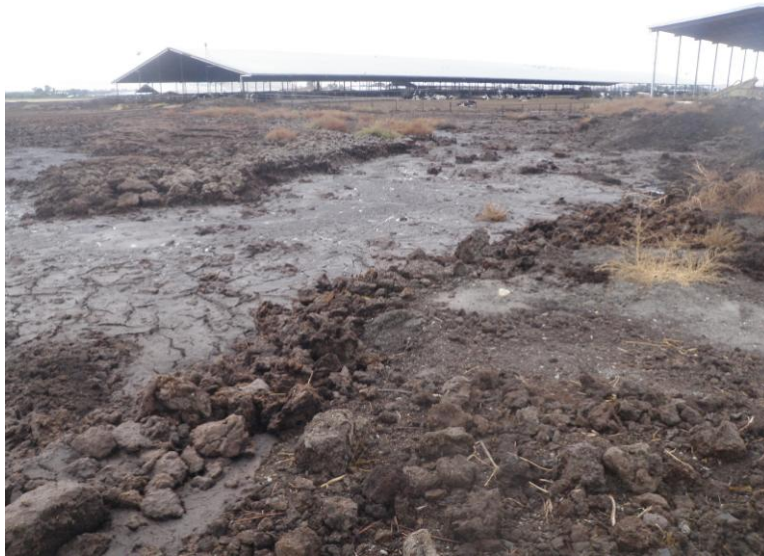
Photo 20: Looking southwest at the 3-4 acre slurry area; the area still contains a significant amount of solid manure, slurry manure, and wastewater.
